# **Will fit vs actual UA2 doser.**

CES CPS Team

27-Aug-2019

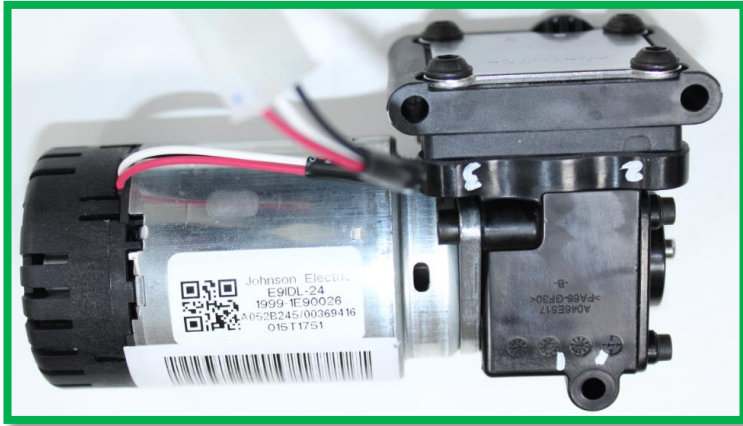
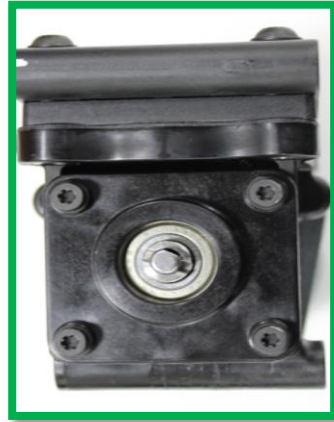
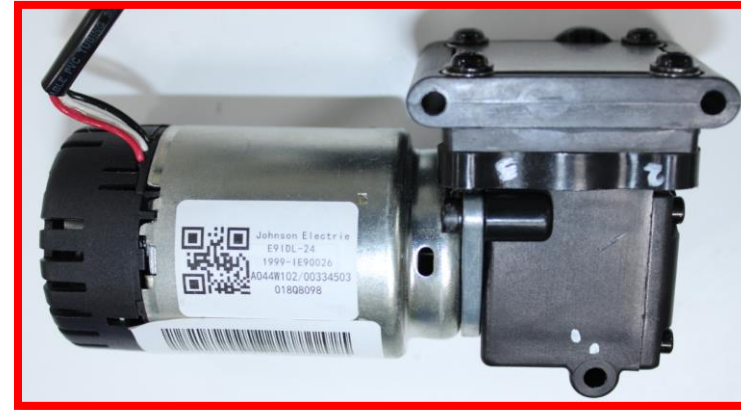
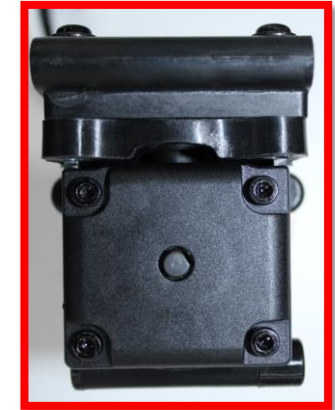
# Pump

**What are the differences?** :- Barcode, Part no. and scan bar is dissimilar. Covered Rotating shaft area from RH side view and bottom view of pump (manifold fitment side) and not visible

**Effect and Explanation:** - Part tracking & identification during any failure investigation will be difficult without barcode & part no.

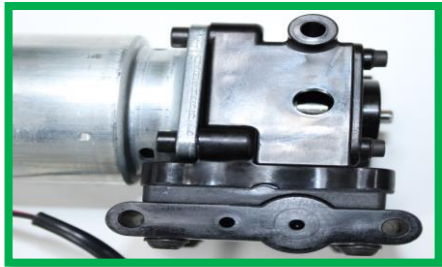
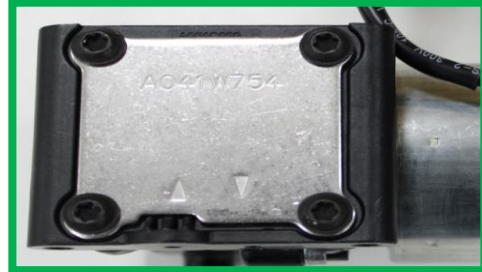
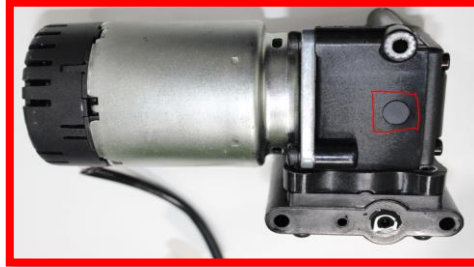
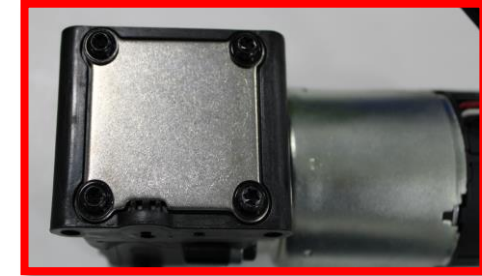
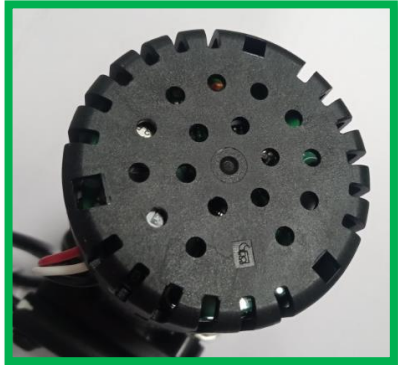
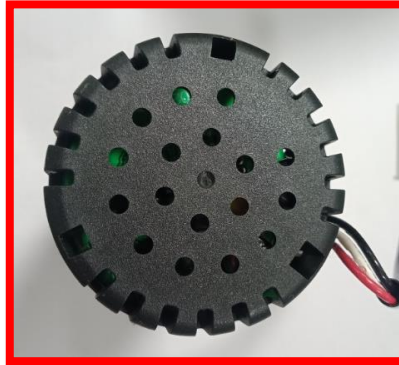
# Pump

**What are the differences?** :- No symbol available on PCB covered body. Part no and Fluid IN arrow marks not present on read valve side metal plate. overtighten marks on below 1st screw mounting surface . No part no and numbers clocks available on plastic body of Pump in between 3 screw mounting passage (from Top View)

**Effect and Explanation:** - Part tracking & identification during any failure investigation will be difficult without barcode & part no., over torque can damaged pump internal part & may cause failed to prime issue. During our investigation we found FC1682

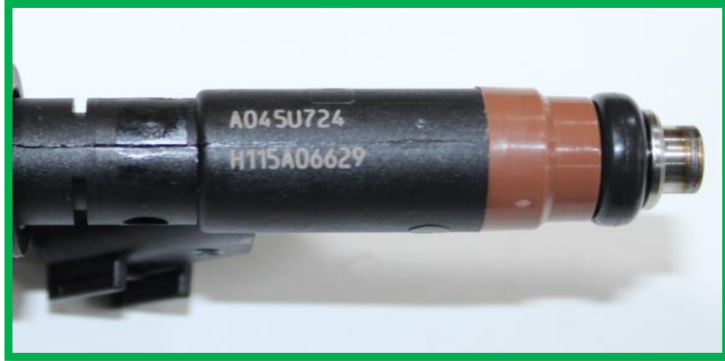
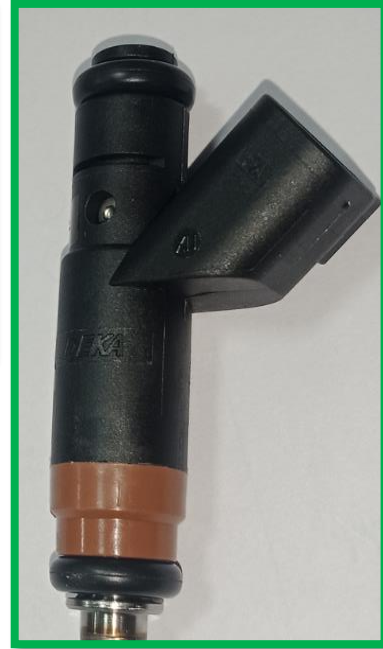
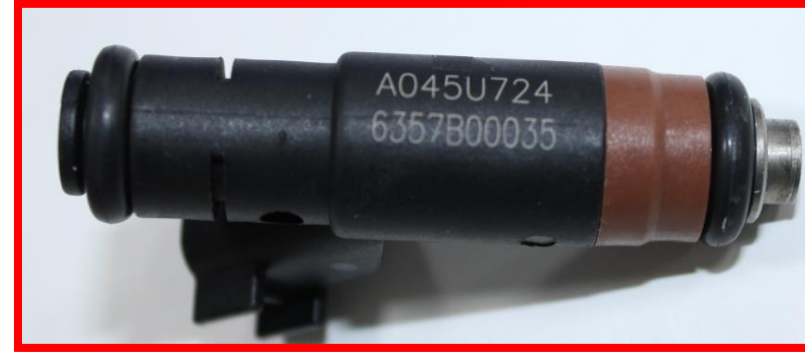
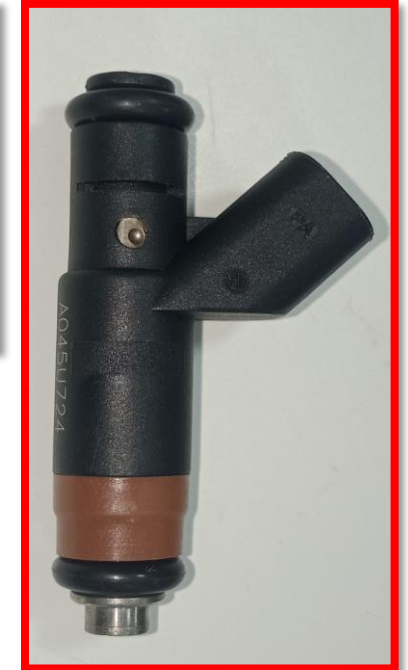
# Injector (MV)

**What are the differences?** :- DEKA name is not available and sr no. series is different. And Part no/sr.no font is dissimilar. Nozzle tip is diverse and spray hole size is bigger than genuine doser. Rupture marks found on back side of MV (plastic surface)

**Effect and Explanation:** - MV is critical component to measure the amount of DEF so using a non standard MV can cause inaccuracy in dosing and hence it'll impact on Nox conversion. Bigger hole size in MV can doser extra DEF which can cause DEF crystallization issue.

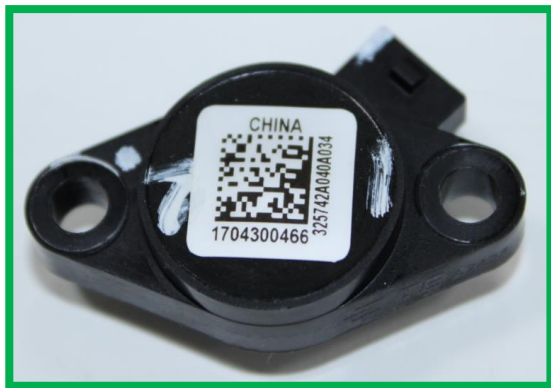
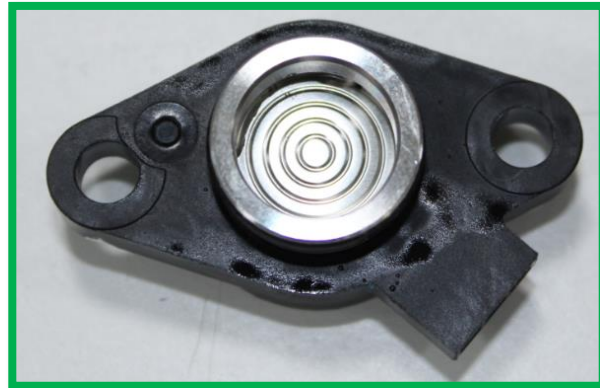
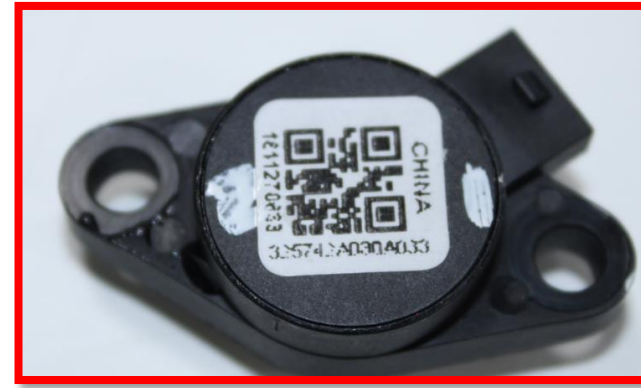
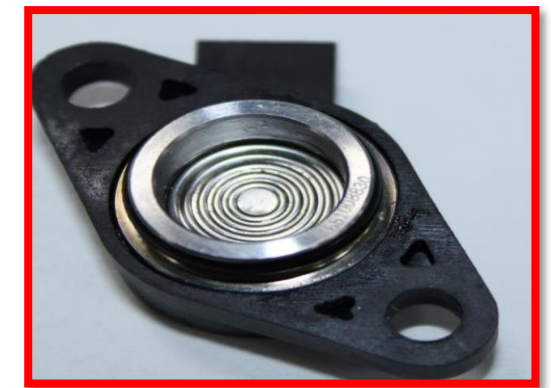
# DEF Pressure Sensor

**What are the differences?** :- Barcode and part no is changed . Circles present inside the sensing element of pressure sensor are differently designed.

**Effect and Explanation:** - Internal design of pump are different from genuine UA2 doser which may change pressure sensor abilities and thus impact overall dosing. Most of dosing unit logic in UA2 dosers are pressure sensor calculation based.

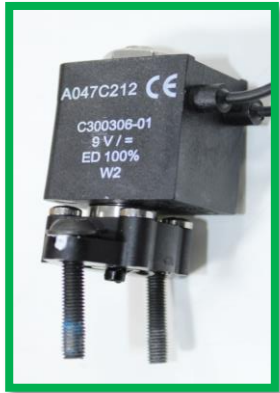
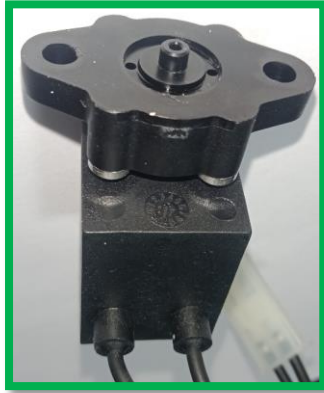
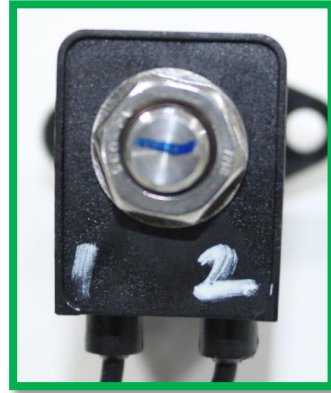
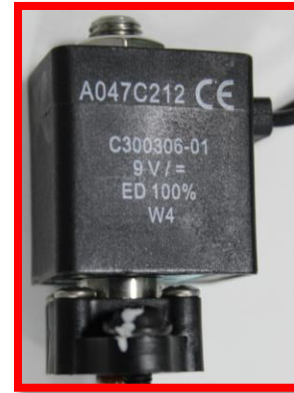
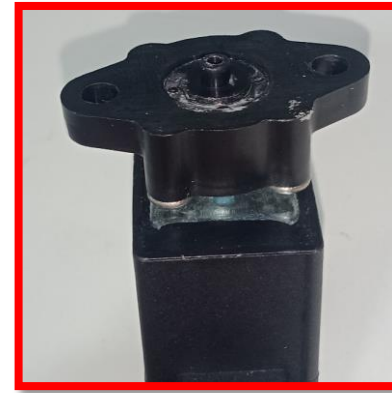
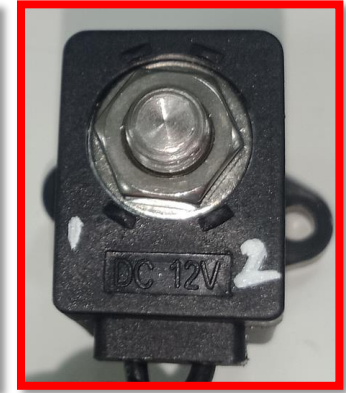
# Bypass Valve

**What are the differences?** :- ED100% W4 is mentioned instead of W2. Serial no not available. DC12 V is written on top side . Plunger stud has over length and assembly and material looks different ; sheet metal is present on assembly body instead of plastic. Number circle is not available on body

**Effect and Explanation:** - Design is differed from genuine BP valve, and can affect to the functionality of BP valve which can lead to DEF crystallization in doser because of incomplete purging event.

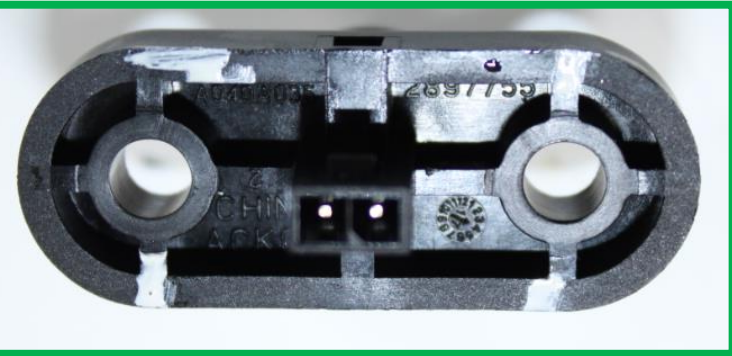
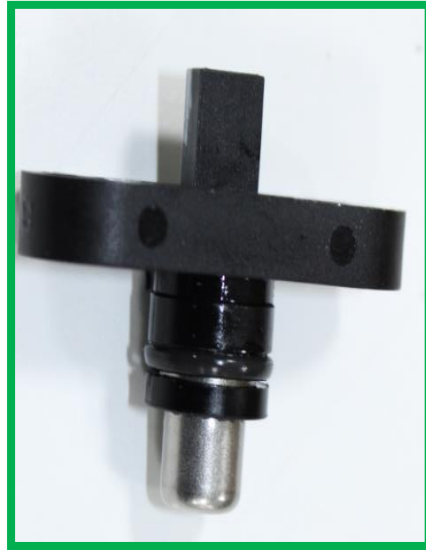
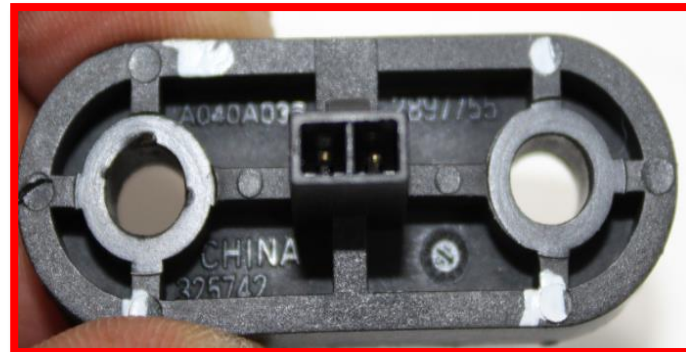
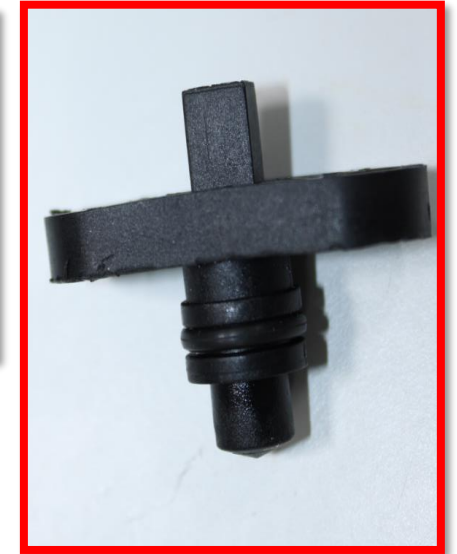
# Temperature Sensor

**What are the differences?** :- Plastic sensing element is used and CHINA 325742 is mentioned instead of CHINA ACKCV.

**Effect and Explanation:** - Willfit Temp sensor is without steel cap which may introduce DEF inside the sensor & FC may triggered.  
Incase of heating requirement willfit temp. sensor will not work & will triggered Temp sensor functionality related FC.

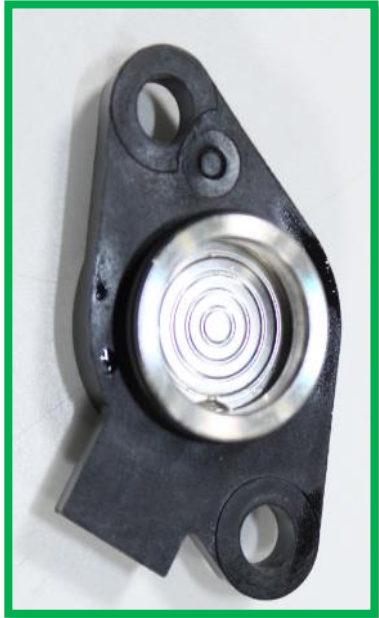
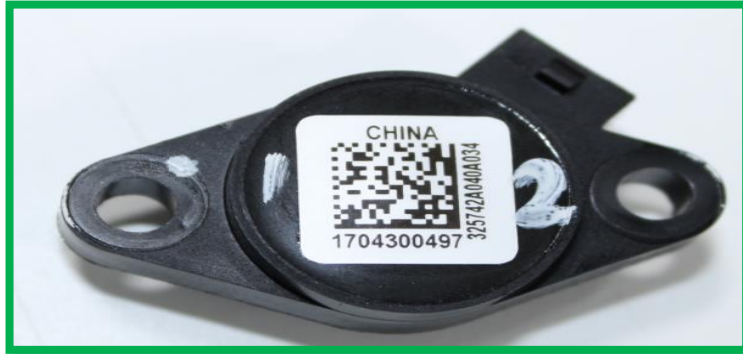
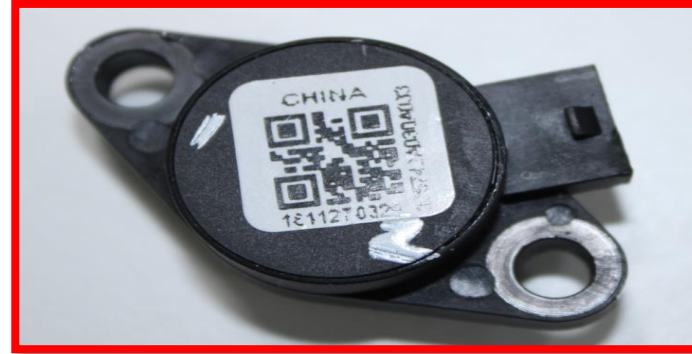
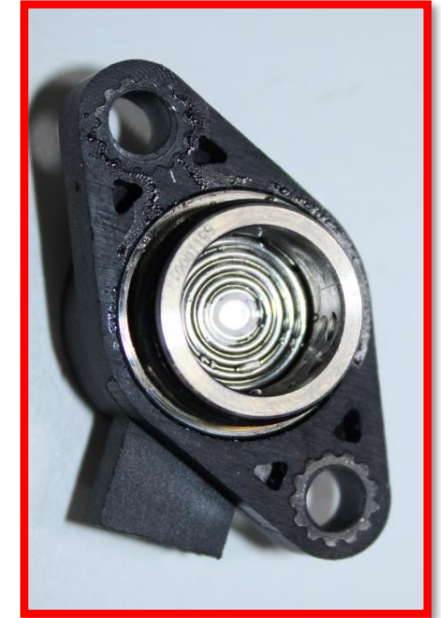
# Mixed Air Pressure Sensor

**What are the differences?** :- Barcode and part no is changed . Circles present inside the sensing element of pressure sensor are differently designed.

**Effect and Explanation:** - Internal design of pump are different from genuine UA2 doser which may change pressure sensor abilities and thus impact overall dosing. Most of dosing unit logic in UA2 dosers are pressure sensor calculation based.

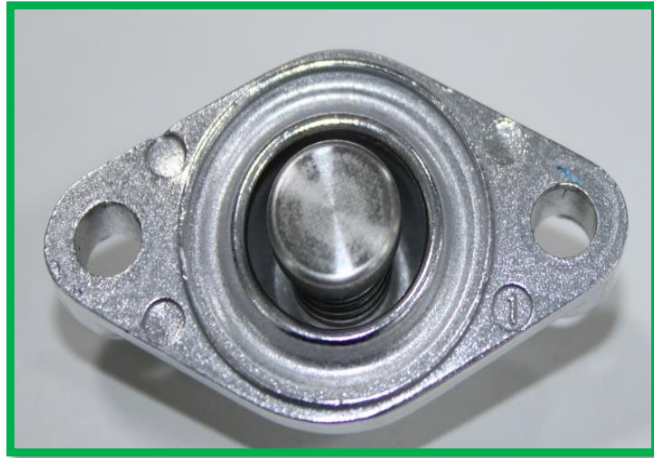
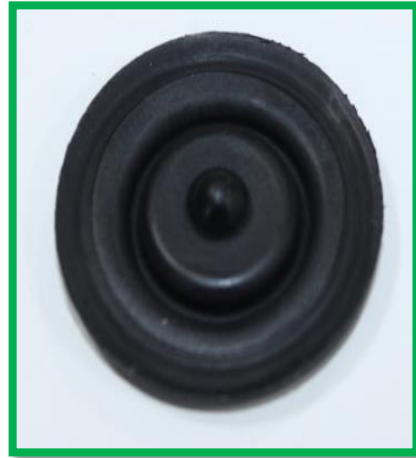
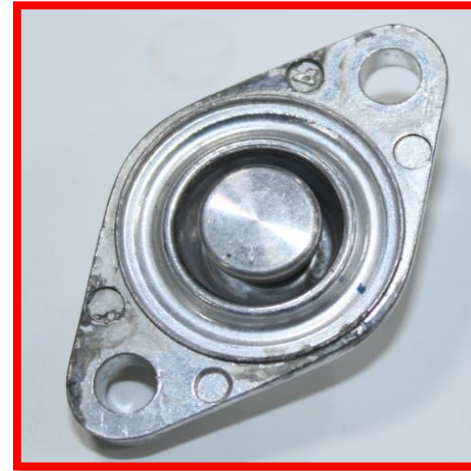
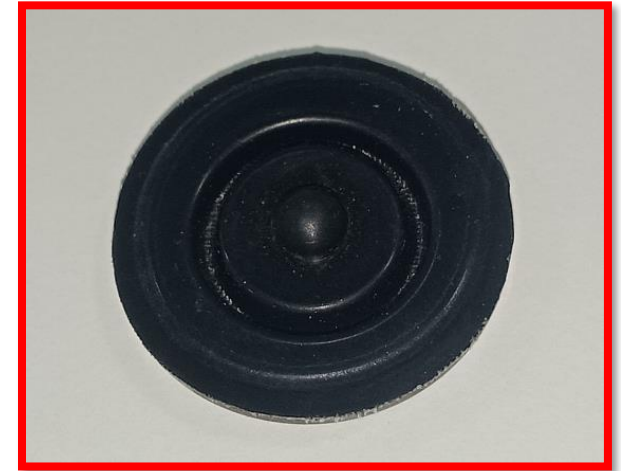
# Check Valve & Diaphragm

**What are the differences?** :- Blackish mark on check valve and shining also low. Inner shape of diaphragm is different and hardness also slightly more due to material may change.

**Effect and Explanation:** - DEF Metering rate is not as per spec, having the FC 3568 when connected to Calterm.

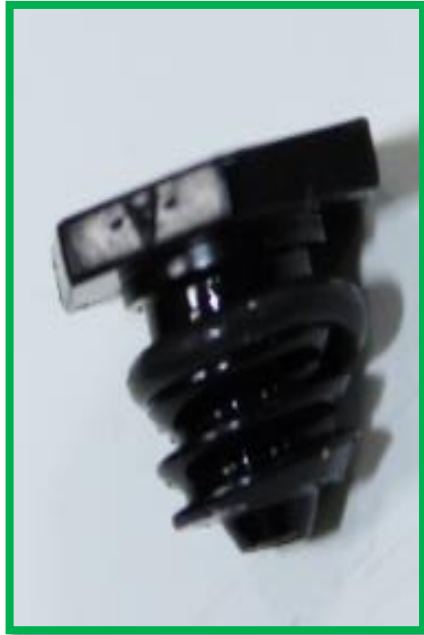
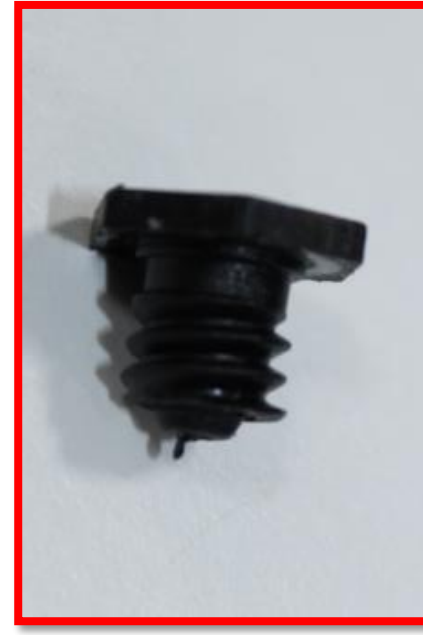
# Air Curtain

What are the differences? :- No O ring on threaded area

Effect and Explanation: - May cause to trigger the pressure sensor related FC. In absence of o ring DEF will leak inside doser & can damaged all the internal parts of doser.

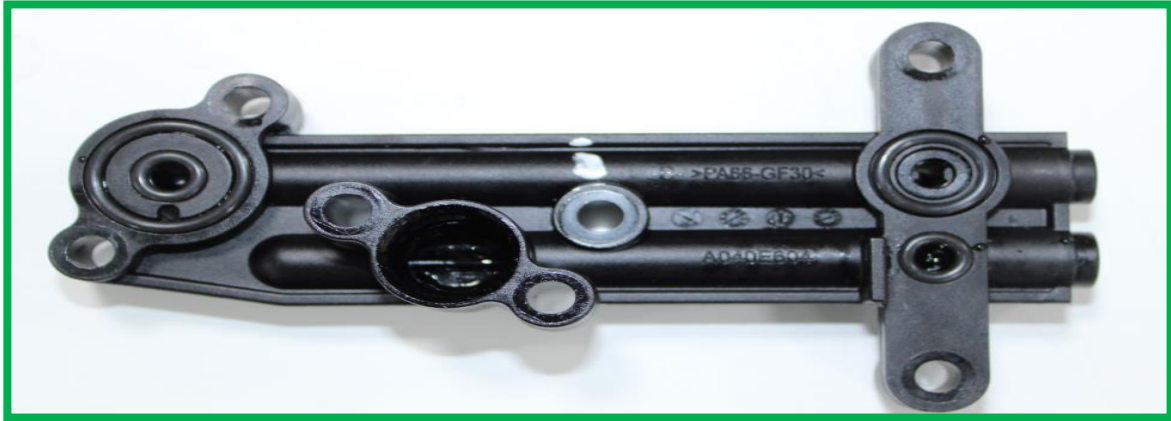
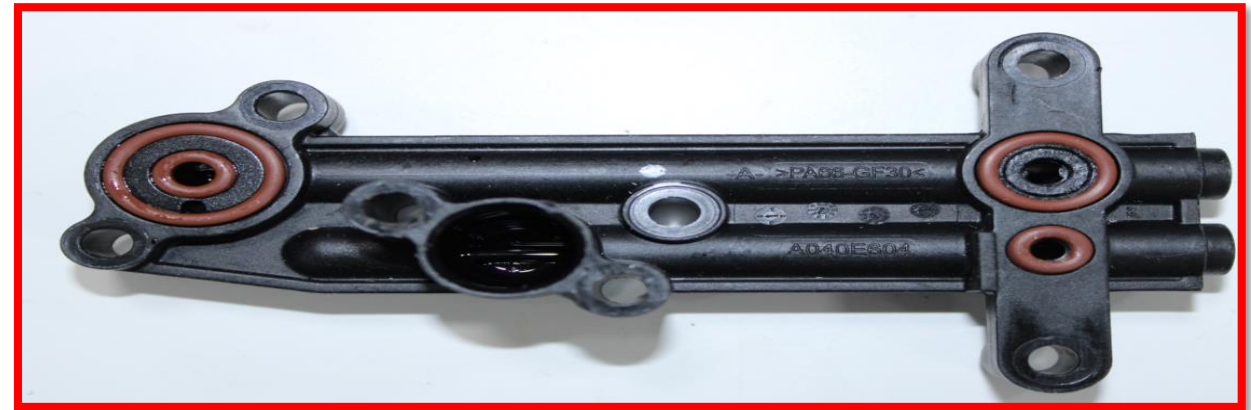
# Manifold

What are the differences? :- A>PA66-GF30< is mentioned instead of B>PA66-GF30< and 2 is mentioned on top side of Manifold instead of 1

Effect and Explanation: - Non standard O ring DEF will leak inside doser & can damaged all the internal parts of doser.

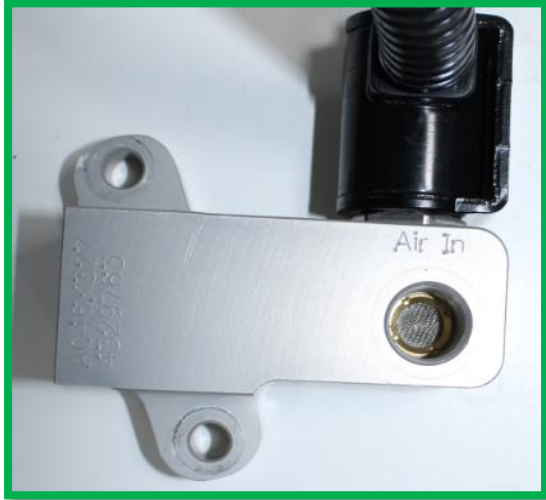
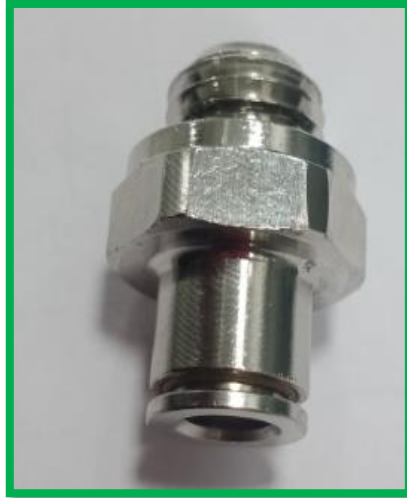
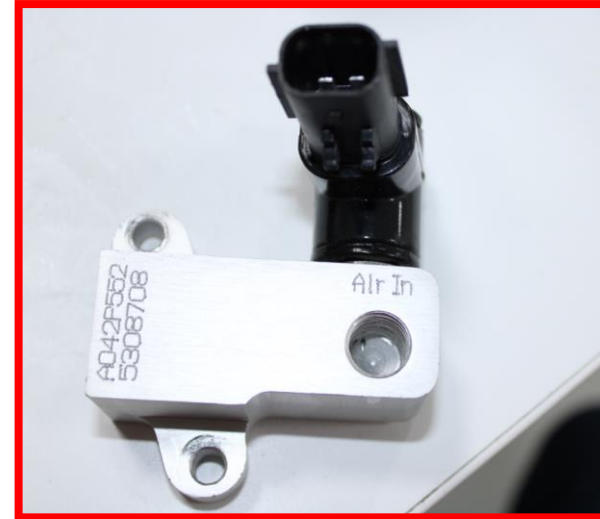
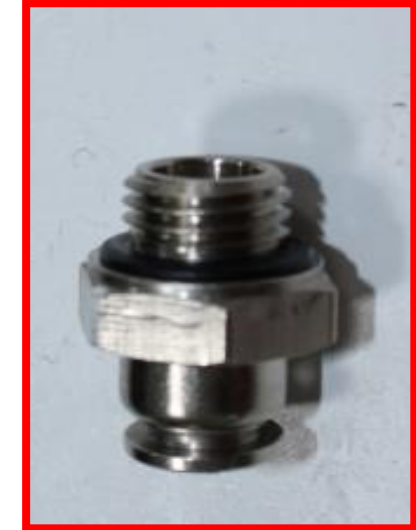
# ASOV

**What are the differences?** :-Air filter screen is not present below the Push fit assembly (after thread finished). Part no.is different .observed harness connector Loosed . ASOV screw material is different . Push fit connector shape is dissimilar.

**Effect and Explanation:** - ID of willfit doser is differ from genuine one, may cause for trigger the FC related to ASOV. ASOV internal parts will damaged because of dust or debris entry inside a doser.

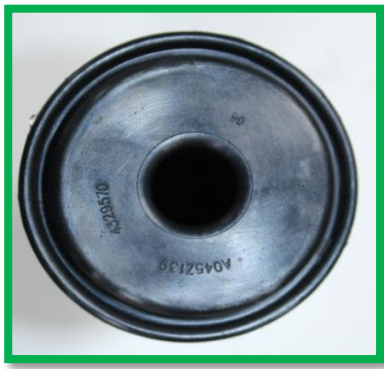
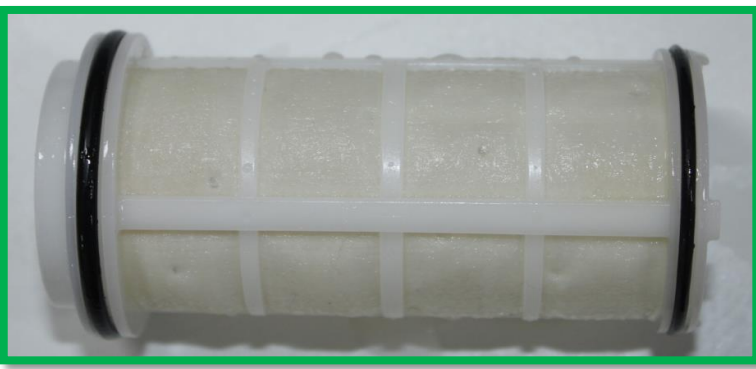
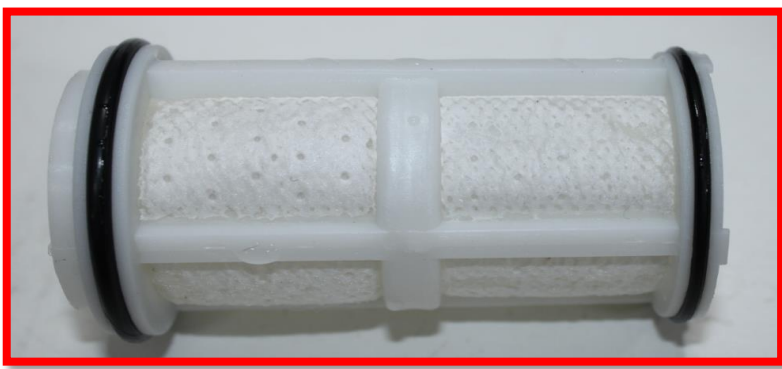
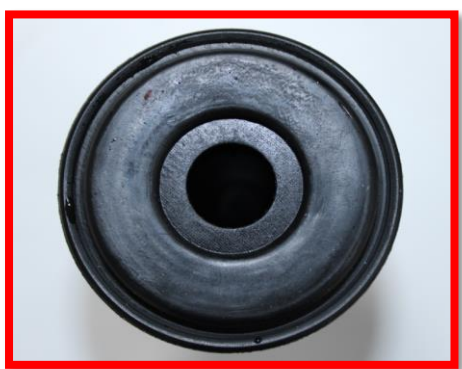
# Filter & Damper

**What are the differences?** :- Part no. and serial no. not present on front view of damper and damper front view shape and inner view looks diverse ; extra groove is available and hole size also slightly bigger. Strainer material also visually looks different.

**Effect and Explanation:** -Non standard filter can allow mud or debris entry inside dosing unit pump & can damaged internal parts. Pump may failed to prime because of non standard design of filters & it can reduce overall life cycle of dosing unit.

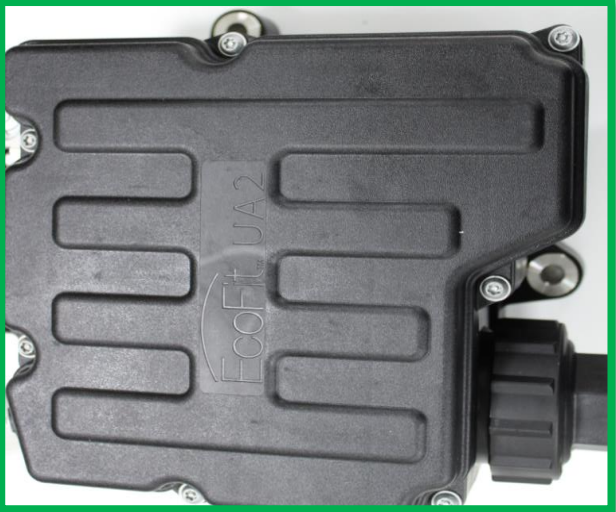
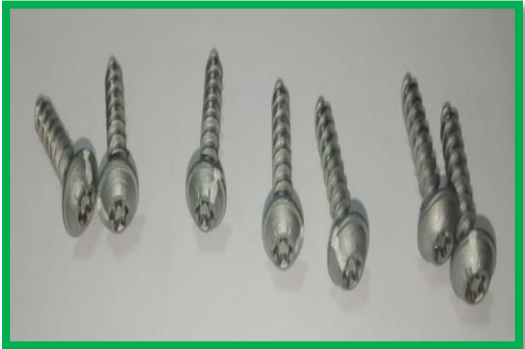
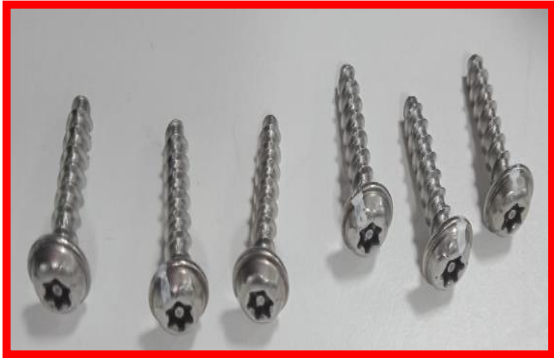
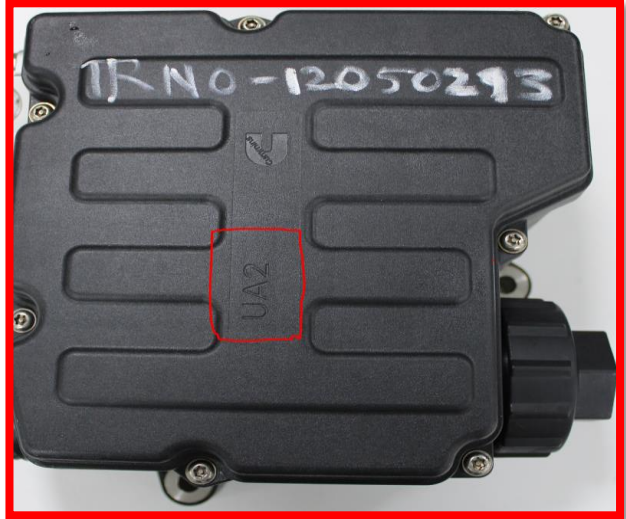
# Top Cover View

**What are the differences?** :- Eco fit Not mentioned on top cover. SS Screw material is used . Top cover part no.is not available inside

**Effect and Explanation:** - Part tracking & identification during any failure investigation will be difficult without barcode & part no.

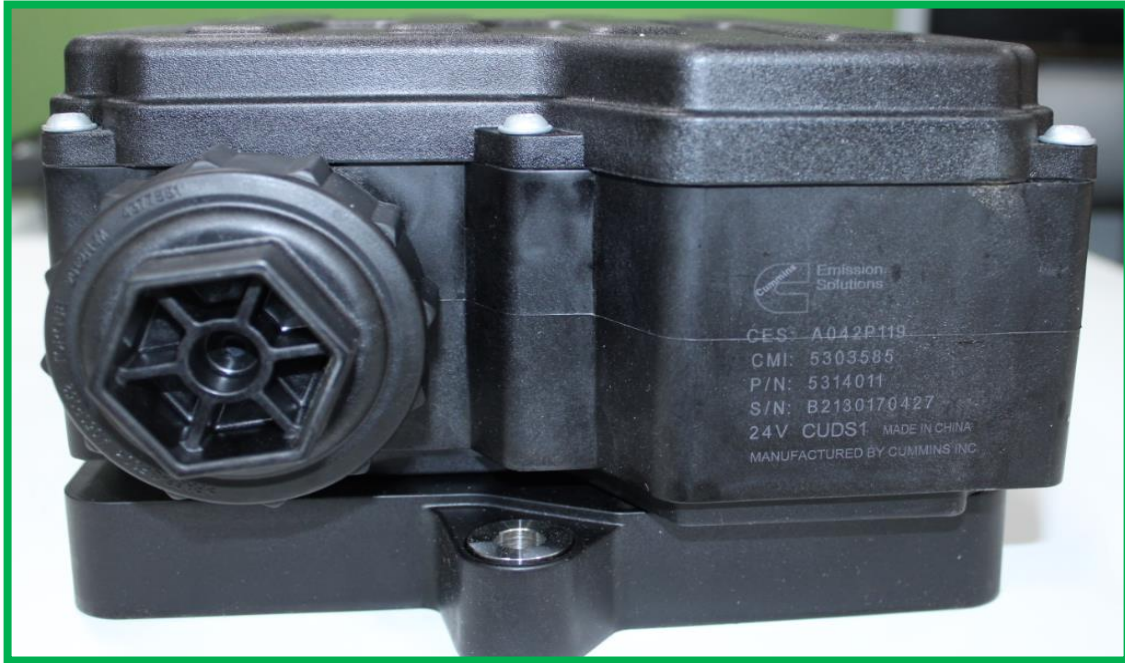
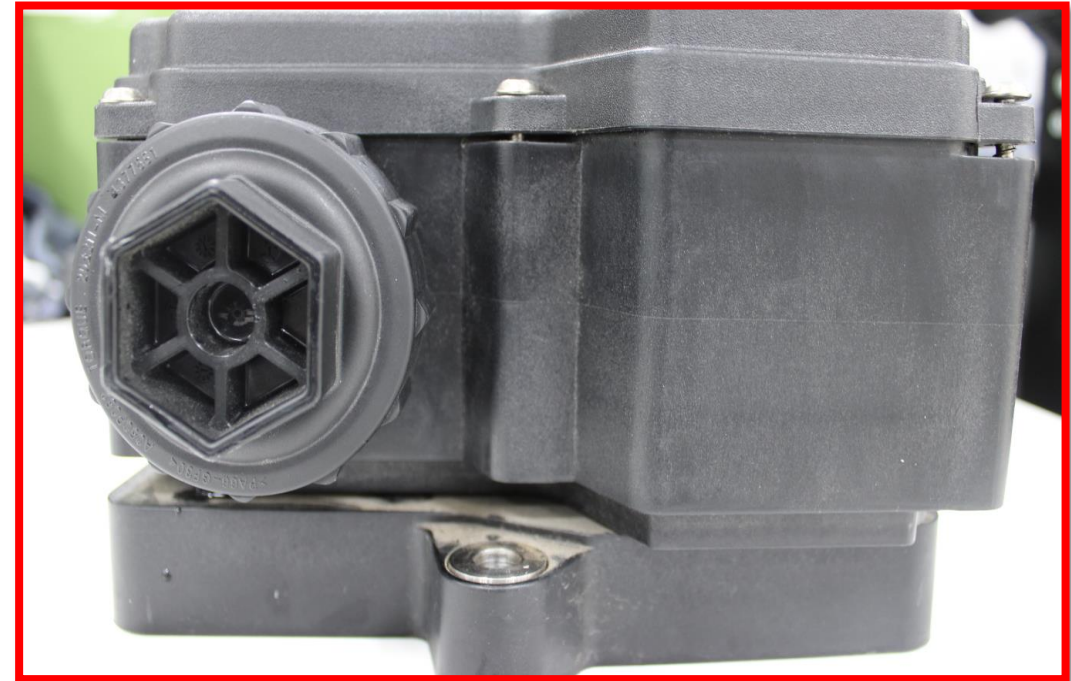
# Filter side View

**What are the differences?** :- Doser part no. and serial no details not marked on will fit doser

**Effect and Explanation:** - Material can be differed from the genuine one, need to do the material analysis for more understanding on comparison. Part tracking & identification during any failure investigation will be difficult without barcode & part no.

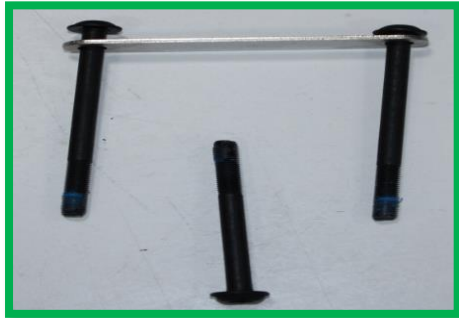
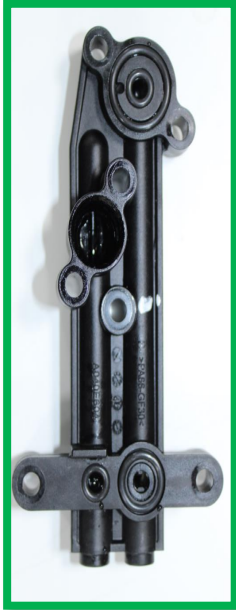
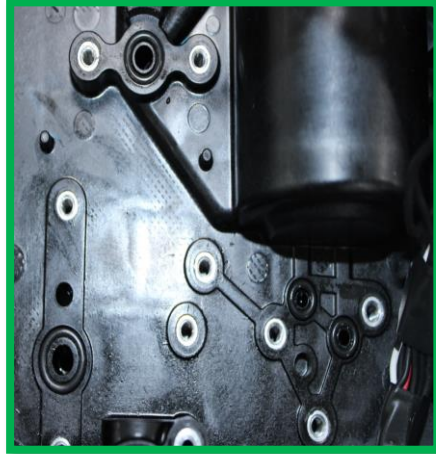
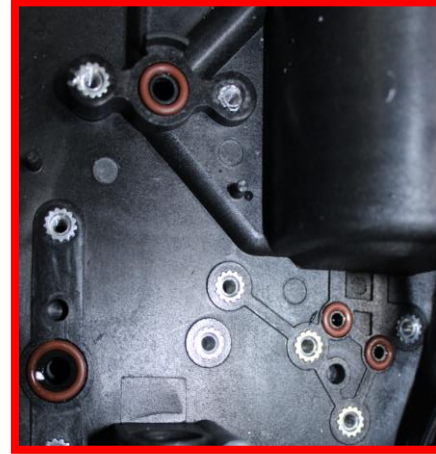
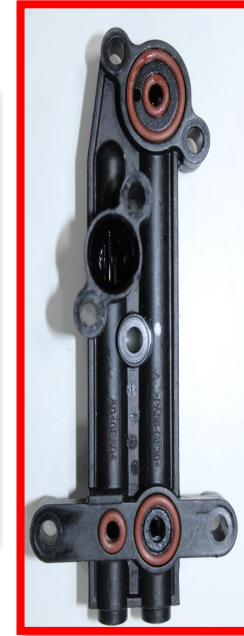
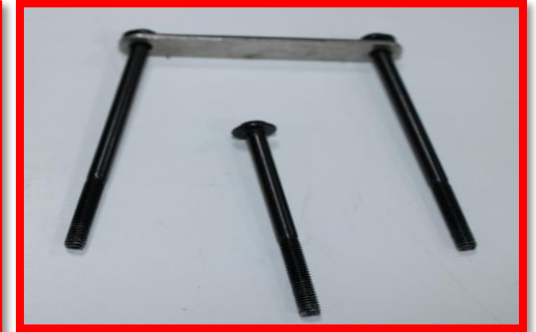
# All O rings & Screws

**What are the differences?** :- Brown colour O rings is used everywhere , All Screw material looks different and slightly harden . Female thread shapes (inner plastic body) is differently designed than CES doser for all screw assembly. No blue colour marks on thread area.

**Effect and Explanation:** - Material can be differed from the genuine one, need to do the material analysis for more understanding on comparison. Non standard O ring DEF will leak inside doser & can damaged all the internal parts of doser.

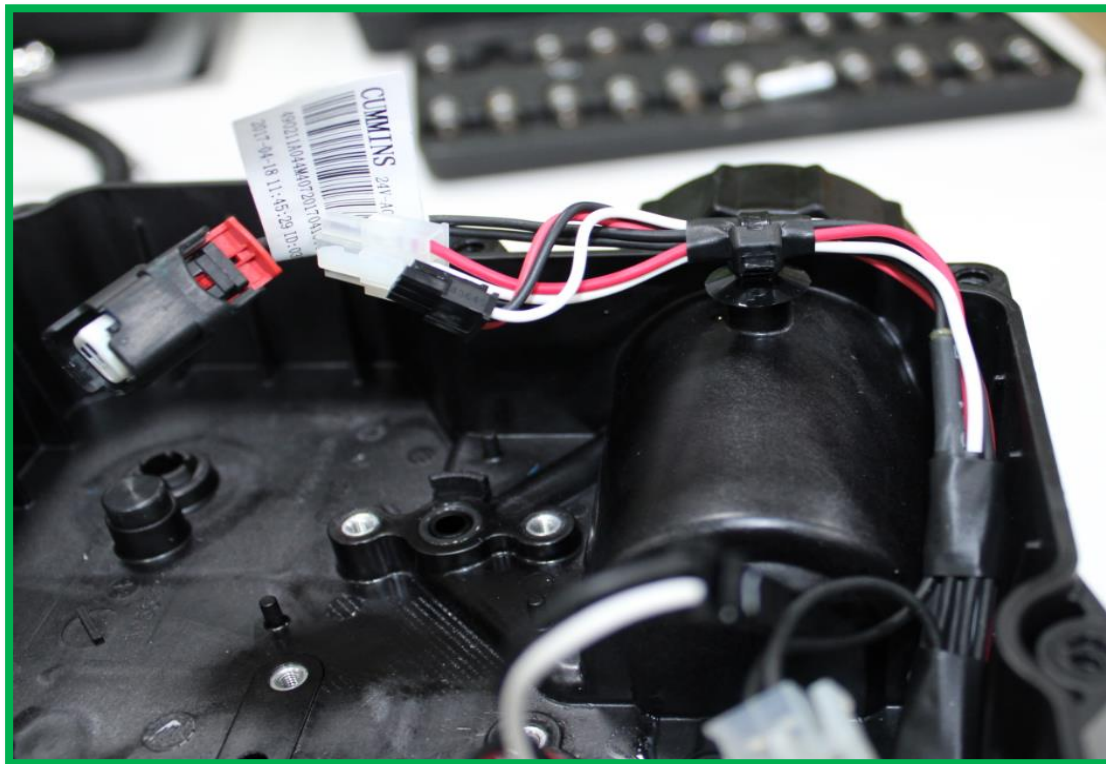
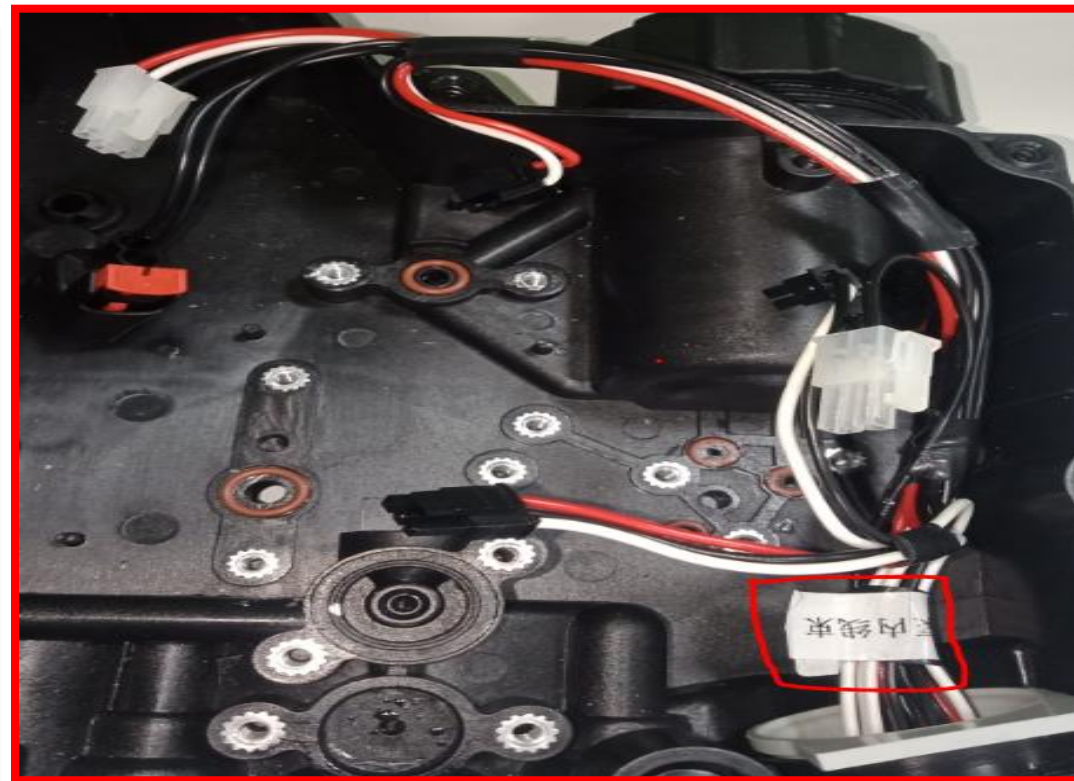
# Doser Harness

**What are the differences?** :- Part no, serial no and scan bar tag is not available on harness and harness holding screw also not offered.

**Effect and Explanation:** -Electrical failure can happen by using not using CES recommended harness
