# **Will fit vs actual UA2 doser.**

CES CPS Team

27-Aug-2019

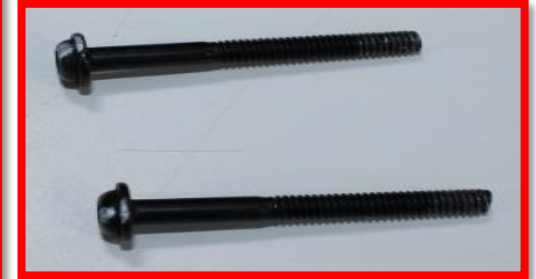
→	Will-fit Part

**What are the differences?** :- Brown colour O rings is used everywhere , All Screw material looks different and slightly harden . Female thread shapes (inner plastic body) is differently designed than CES doser for all screw assembly. No blue colour marks on thread area.

**Effect and Explanation:** - Material can be differed from the genuine one, need to do the material analysis for more understanding on comparison. Non standard O ring DEF will leak inside doser & can damaged all the internal parts of doser.
